DRYING OF HORIZONTAL TIMBER ROOF ELEMENTS AFTER WATER DAMAGE

Javad Darvishi¹, Samee Ullah¹, Kristine Nore², Mari Sand Austigard³

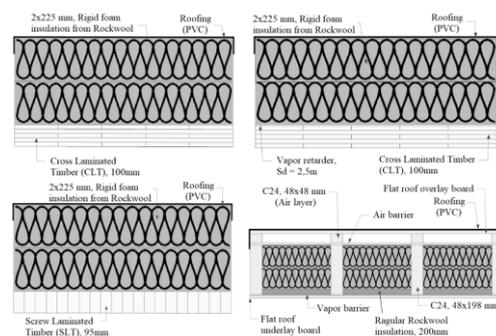
Figure 1: Structure of the test elements

A drying test comparing three compact roof elements with laminated wood and one typical timber framed roof with ventilated cladding has been conducted during the period 05.07.2017 – 06.08.2018. The roof systems investigated were two CLT – elements with and without vapor retarder, one screw-laminated timber element (SLT) and one timber frame element with vapor barrier placed under insulation, and weather barrier on the top of the insulation. The horizontal dimensions of the elements were 1x1 metre, and the height varied between systems as shown in fig. 1.

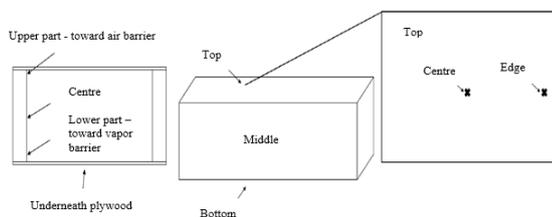
Figure 2: Location of HygroTrac sensors, timber framed- (left side) and laminated timber elements (right side).

Each element was equipped with 4 HygroTrac sensors that monitored temperature, relative humidity (RH) and moisture content. For laminated timber elements, two of the sensors were placed on the top surface (one in the centre and one towards the edge), one sensor was drilled into the centre of the element (from the bottom), while the last sensor was placed on the bottom surface of the element. In the timber framed element sensors were placed on the top, centre, and bottom of the middle beam of the roof system, and underneath the plywood. The sensor locations are shown in Figure 2.

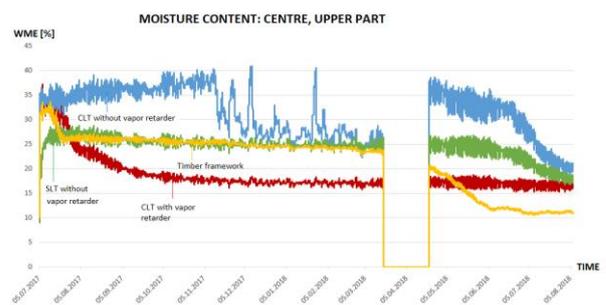
Figure 3: Registered moisture content for centre, upper part until 06.08.2018

The drying test has been done in an outdoor environment, which generally lead to a slower drying process for the elements – especially in the winter period. As shown in figure 3, all roof constructions have a stable drying process except CLT without vapor retarder. Due to power failure the graphs show a gap from the middle of March 2018 to the middle of April 2018. After the power failure the graph for “CLT without vapor retarder” shows an increase in moisture content (from 28% to 38%). Since no extra moisture has been added to the element, the best

explanation seems to be that the sensor didn’t work properly from approximately November 2018 until the power failure. Since the vapor retarder has protected the CLT with vapor retarder from the added water, this element dries out best among the laminated timber elements. It should be noted that “Timber framework” element dries faster than all laminated timber elements in the summer period (middle of April 2018 until August 2018). This illustrates the effect on drying from a smaller wood cross section. On the other hand, timber framework has been shown to have somewhat higher risk of mould growth than laminated timber elements when exposed to prolonged wetting. [4]
